Residential HVAC System Analysis: Furnace Temperature Rise, Static Pressure, and Air Flow

Dominic Pecchia

Mechanical Engineer/Product Designer

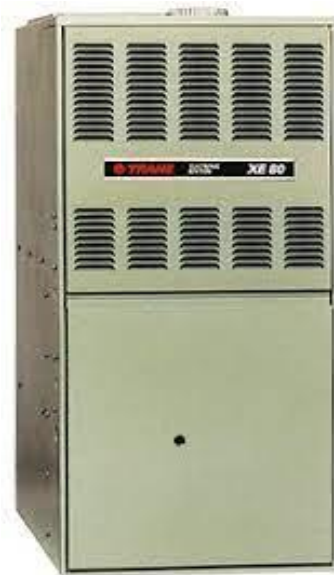
In this analysis, a customer's furnace/ductwork system was used to obtain results regarding the affect, or lack of affect, that the Impeccable Air Filters had on the air flow. More specifically, a Trane XE80 Gas Furnace was used and can be seen in Figure 1 below.

Figure 1: Trane XE80 Gas Furnace Model #TUD100C948J

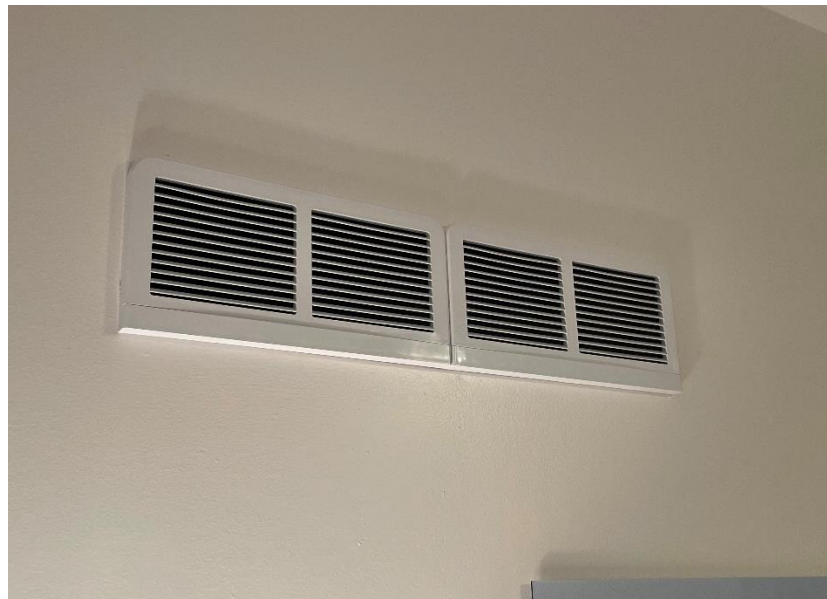
The Impeccable Air Register is a two-piece register that consists of a backplate that gets secured to the wall and a friction fit front cover that opens for very simple filter changes. The register is 15.75" wide by 7.75" tall - created to fit as a direct replacement for the most universally used residential ductwork opening - the 14" by 6" opening. To accompany the functionality, the registers were designed to be durable and aesthetically pleasing. They consist of rounded corners, no exterior screw construction, they are made of ABS Plastic - so they will not dent, scratch, or rust - they can come in different colors or can be painted to match any existing home décor, and the front grille covers are dishwasher safe. An image of an installed register can be seen in Figure 3.

Figure 3: Impeccable Air Return Registers

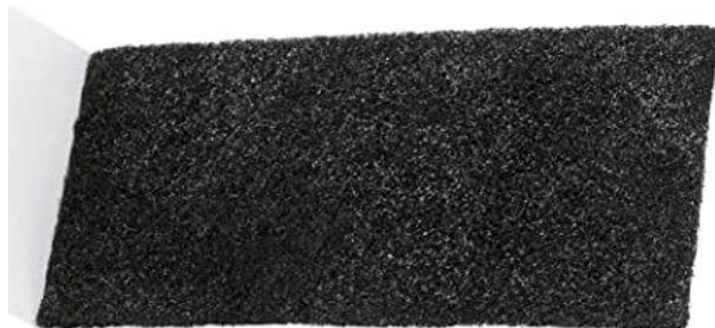
The Impeccable Air Filter is rated MERV 6, consists of Activated Carbon, and is coated with PRO-Techs® Antimicrobial Disinfectant to maximize the number of contaminants that are captured. An image of the Filters that are used is shown in Figure 4.

Figure 4: Impeccable Air Filter

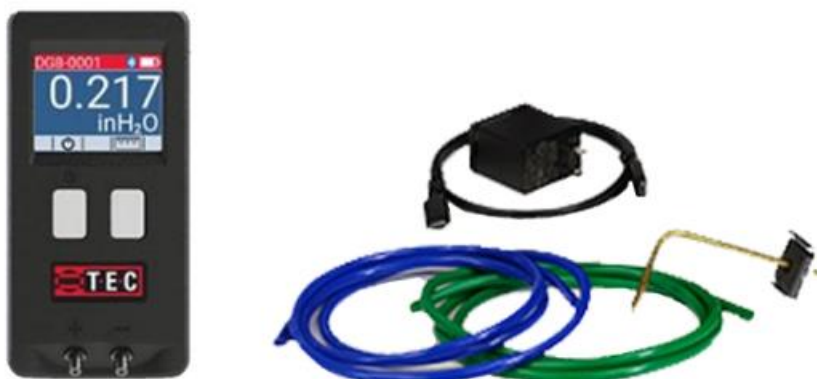
When the Filters were installed the static pressure and flow rate measurements were recorded using a manometer and flow plate. The digital manometer that was used was a DG-8 digital pressure gauge from a company named The Energy Conservatory and can be seen in Figure 5. Likewise, the flow plate that was used was a Digital True Flow HVAC System Air Flow Meter from the same company and is shown in Figure 6.

Figure 5: DG-8 Digital Pressure Gauge Manometer

Next, the DG-8 Digital Pressure Gauge Manometer was used to record static pressure throughout the system with and without the Impeccable Air Filters installed. The pressure was measured in the return plenum and the supply plenum, and the total static pressure was recorded using Equation 3:

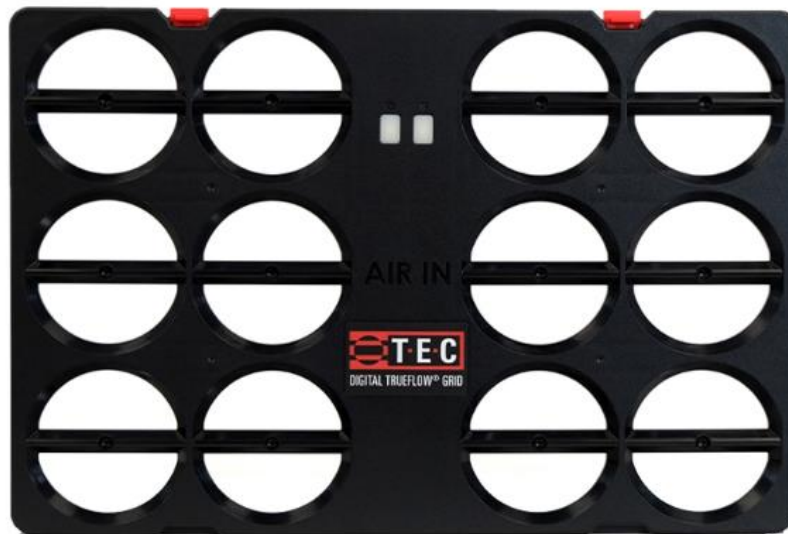
Figure 6: The Energy Conservatory Digital TrueFlow HVAC System Airflow Meter

Finally, the air flow rate was measured using the Digital TrueFlow HVAC System Airflow Meter to record the air flow throughout the system with and without the Impeccable Air Filters installed. When the air flow was recorded, it was compared to the theoretical air flow
